## REMOVING - REFITTING : FRONT BUMPER

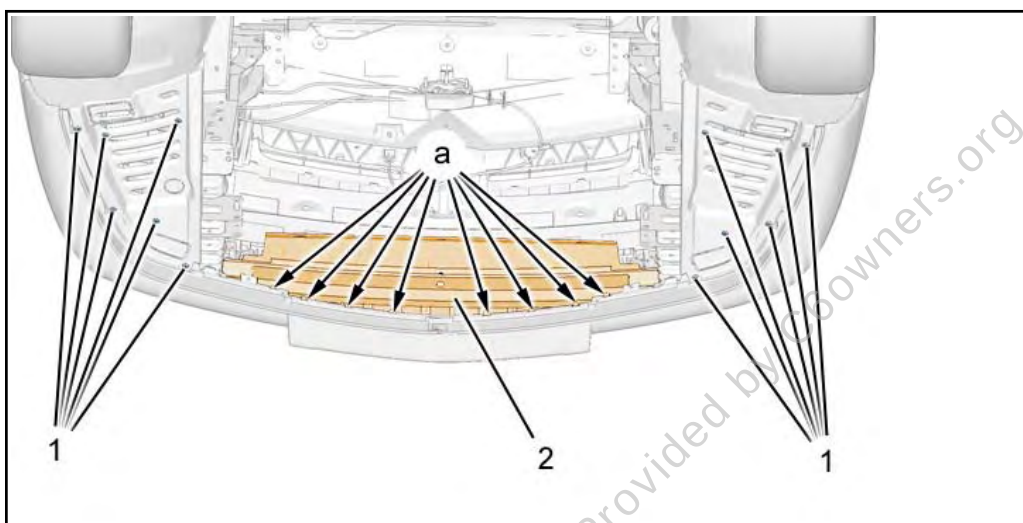
Figure : C4AP1HED

Detach the deflector (2) at "a" .

Remove :

- The deflector (2)
- The screws (1)

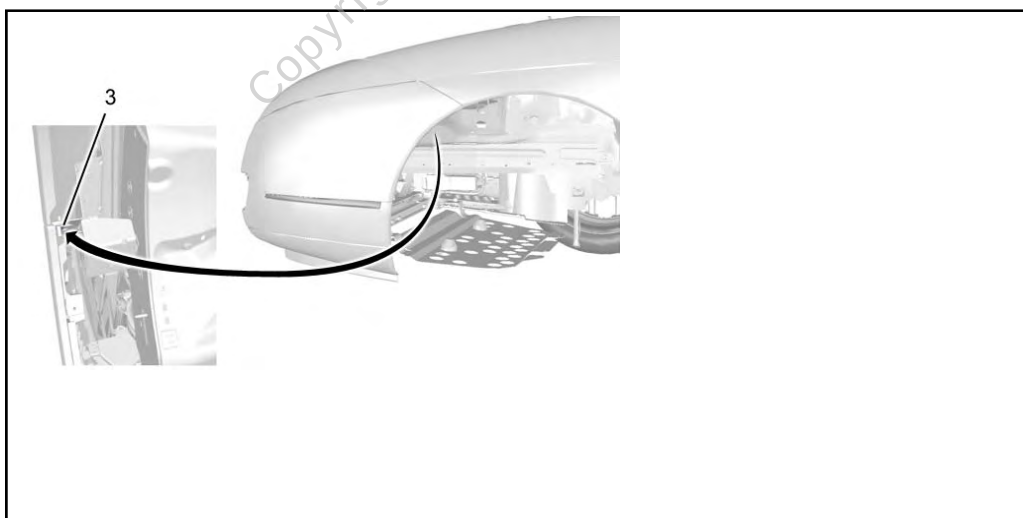
Figure : C4CP15FD

Remove the screw (3) (on each side) .

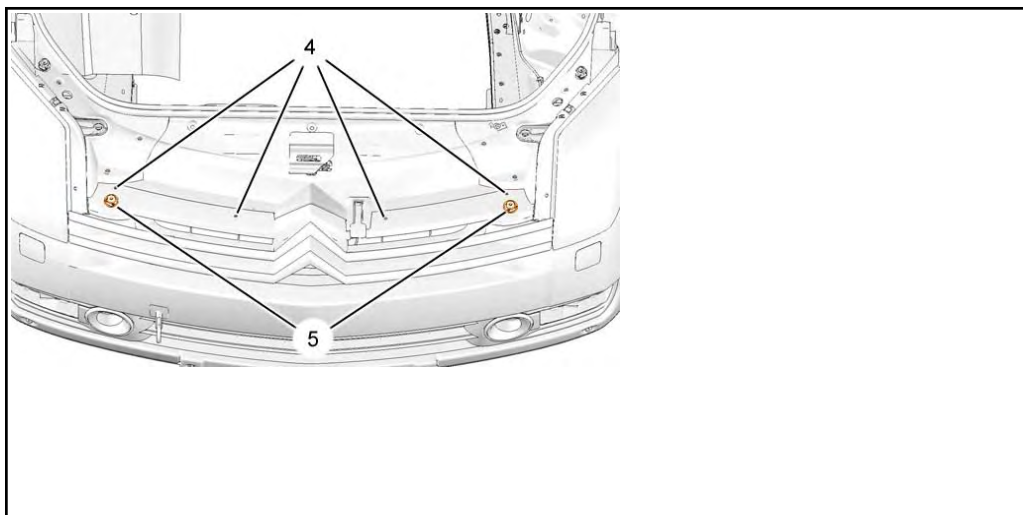
Figure : C4AP1HFD

Remove :

- The plastic pegs (4)
- The bonnet stops (5) unclip

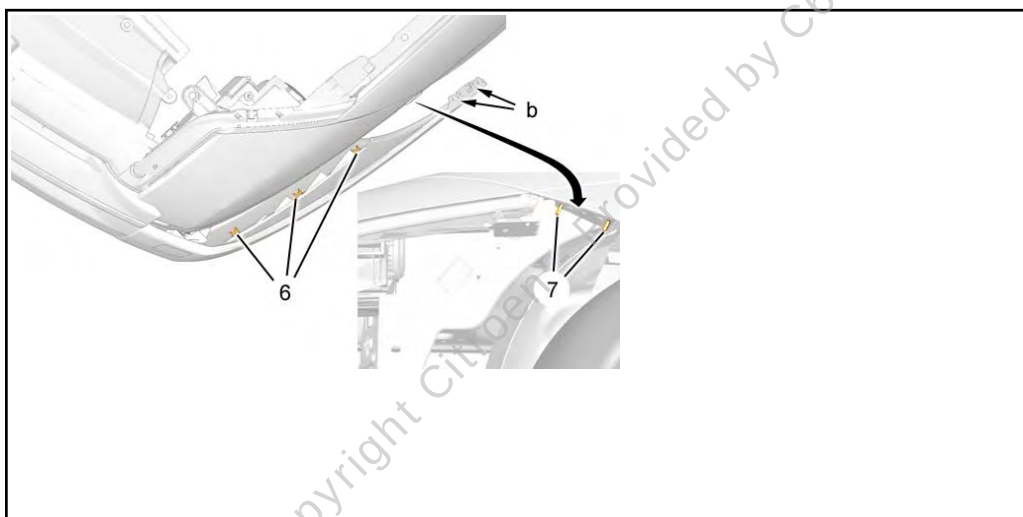
Figure : C4CP15GD

Unclip :

- The slots "b" from the metallic pins (7)
- The clips (6)
- The wiper circuit, from beside the non-return valve (RH side of the vehicle)

Disconnect the 2 connectors of the electrical harness (RH side of the vehicle) .  
Remove the front bumper .

**CAUTION** : Engage the clips (6) in the front wing, and the notches "b" on the metallic pins (7) of the front wing (on each side) .
